# RUBBER LINED IONIZATION CHAMBER REPAIRED WITH BELZONA

ID: 8320

Damage of the original rubber lining of an ionization tower

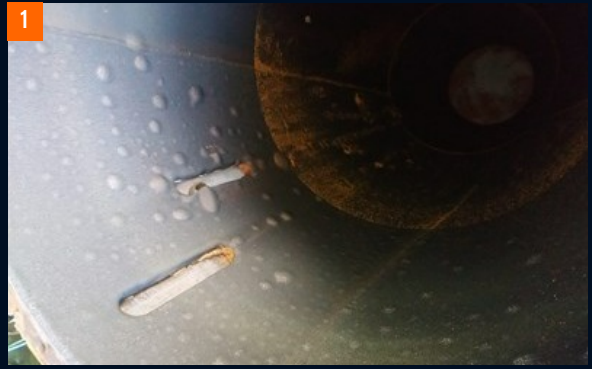
1. Damaged rubber lining
2. Removing of damaged lining and surface preparation
3. Second layer of 2121 is being applied
4. Finished application
