# RUBBER LINED IONIZATION CHAMBER REPAIRED

ID: 8322

Damage of the original rubber lining of an ionization tower.

Pharmaceutical Manufacturer in Hungary

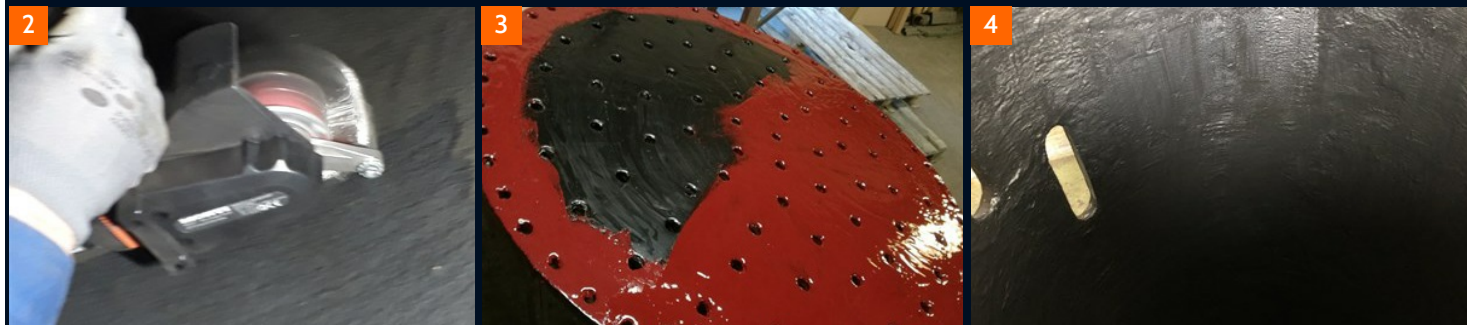
1. Damaged rubber lining
2. Removing of damaged lining and surface preparation
3. Second layer of Belzona 2121 being applied
4. Finished application

Damaged rubber lining has been removed and MBX was used to abrade the surface. Loosen rubber parts were cut off, Belzona 2111 was used to replace missing parts and Belzona 2121 was used to provide a long term and chemical resistant solution.
