# BELZONA REPAIRS AND SECURES FLOORS AND STAIRS

ID: 833

Spalled concrete due to water damage over time.

Corridors and stairs of US government subsidized housing for low income families.

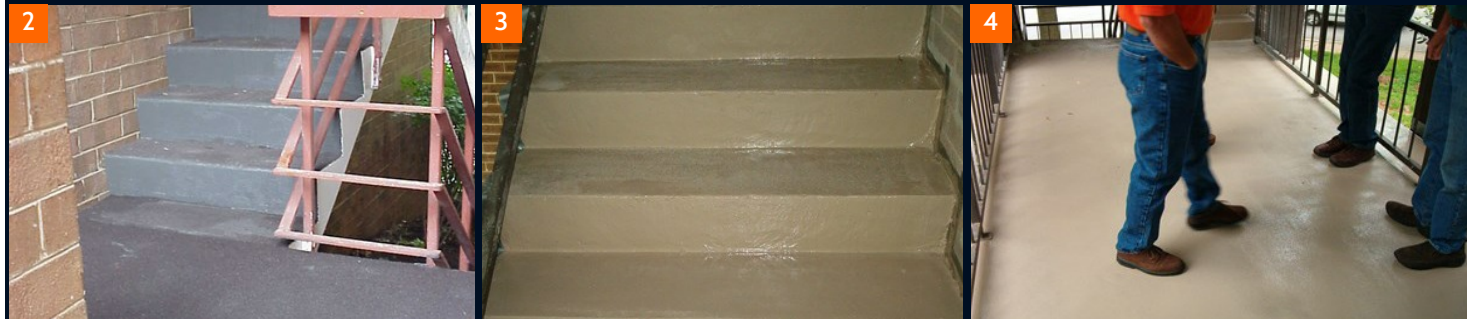
## PHOTOS

1. Damaged stairs.
2. Completed repairs and coating, with Belzona 5811 mixed with a light coat of sand. Undersides of the stairwell were coated with Belzona 3111.
3. Areas repaired with Belzona 4111 & 4141.
4. Finished view of the project.

The worn concrete in this public building had become a health and safety hazard. Damaged areas were rebuilt with Belzona® 4111 & 4141. The underside of the stairwells was coated with Belzona 3111 to prevent moisture from entering the concrete. Belzona® 5811 was used to protect the stairs and balconies, and a non-slip system was created by incorporation of aggregates mixed into the Belzona® 5811. Three years later, this application was still in great condition with only a few areas needing to be touched up.
