# BELZONA REPAIRS THE CLINKER CRUSHER ROTOR

ID: 8333

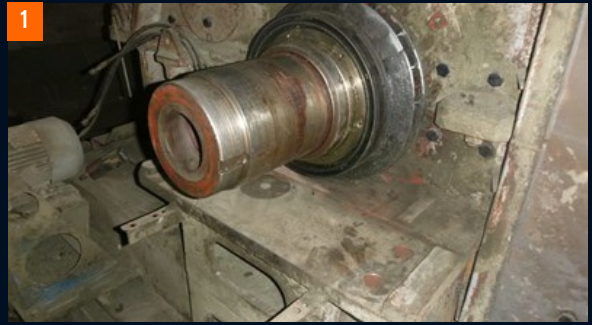
The crusher rotor was damaged due to the loading and working environment.

1. Damaged rotor
2. Rotor after machining, preparing for Belzona 1111 application
3. Belzona 1111 machined
4. The rotor prepared for operation
