# GLUING OF INSERTS IN ENGINE CYLINDERS.

ID: 8334

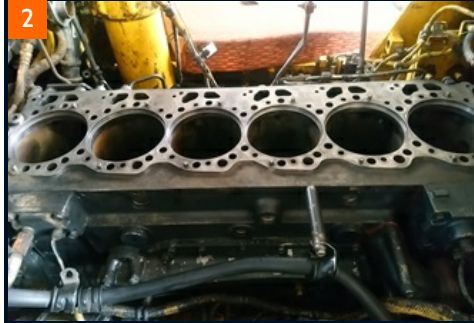
1. Komatsu bulldozer ready for repair
2. 6 engine cylinders with red arrow indication of gluing
3. Inserts and engine cylinders were chemical wash up
4. Engine ready for operation.

Inserts and engine cylinders were chemical wash up. Then Belzona 1591 in thin layer was applied on to inserts (on bearing surface in upper part). Inserts were put in cylinders and cylinder head was assembled. Engine was completed after Belzona 1591 curing time.
