# BELZONAS OPTIMIZED BEARING INSTALLATION

Container Ship Rudder Bearings

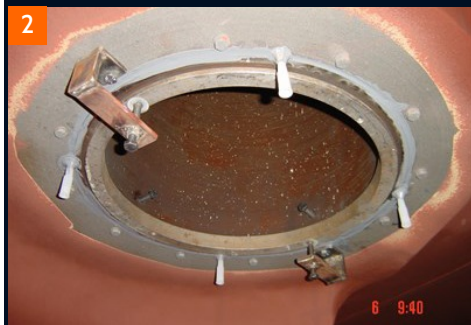
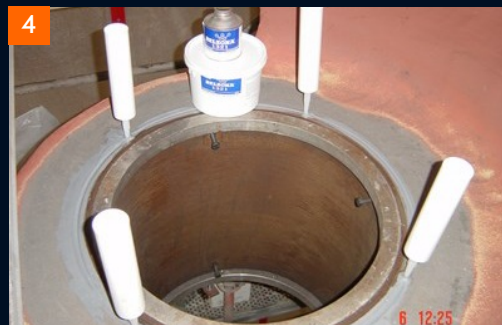
1. Aft end of containership
2. Positioning and sealing of lower annulus
3. Injection of Belzona 1321
4. Vent ports installed to ensure void free application

In this case the synthetic bearing was seated in a steel carrier ring. Bonding with Belzona® 1321 prevents the risk of crevice corrosion and fretting. On this vessel the stainless steel pintle liners are also bonded to prevent galvanic corrosion. Over 30 ships in this class have used this installation method in both Germany and the USA.
