# BELZONA 2311 REPAIRS WASTE INCINERATION PLANT CONVEYOR BELT

ID: 8347

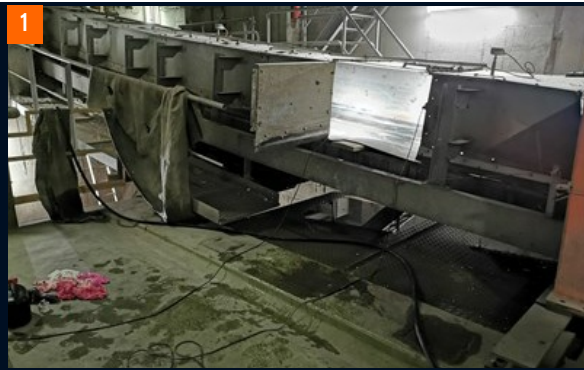
Picture 1 - Conveyor System

A conveyor belt had torn during operation within a waste incineration plant. Conveyor belts transport biomass from the waste heap to shredders or transfer stations.

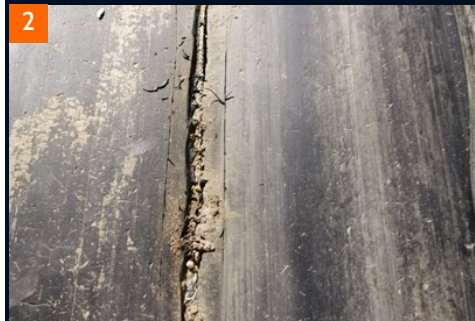
Picture 2 - Conveyor Belt Tear

There were a number of tears in the conveyor belts due to the medium that was being transported along the conveyors. If the belts had torn completely the waste would have spread all over the internal of the operation and also the whole plant would have to be shut down to repair.
