# BELZONA REPAIRS, PROTECTS & IMPROVES PUMP TURBINES IN THE PETROCHEMICAL INDUSTRY

ID: 8349

Water pump impellers were suffering extensively from cavitation and erosion.

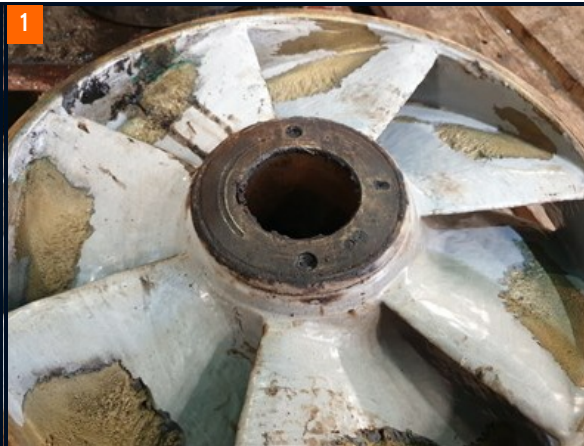
- 1). Damage sustained on the impeller
- 2). Impeller once taken back to the substrate
- 3). Impeller after rebuilding
- 4). Finished product
