# REPAIR OF SEA WATER FLANGE WITH BELZONA ELASTOMER

ID: 8352

Sea water flange on Ro-Ro ship.

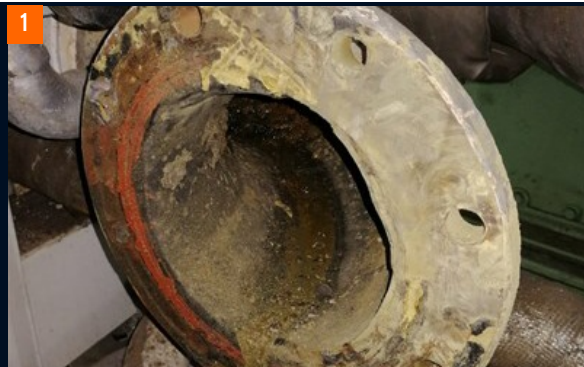
Seawater system flange surfaces were damaged due to corrosion and erosion.

1. Damaged filter flange
2. Abraded flange surface
3. Application of Belzona 2211 on filter flange
4. Application of Belzona 2211 on flange of filter connection pipe
