# LEAKING PARAPETS ON GRADE 1 LISTED CHURCH COATED WITH BELZONA 3131

ID: 8354

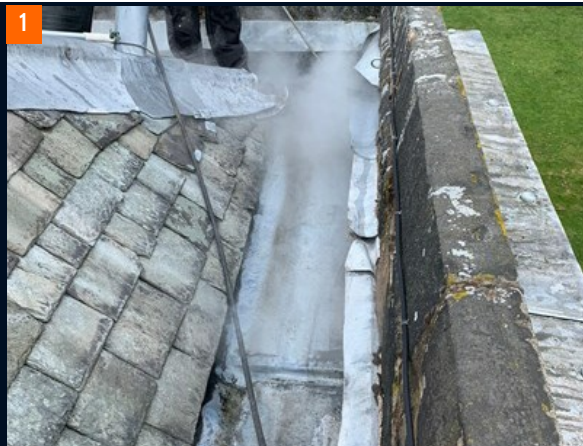
1) Cleaning the substrate with Doff Cleaning machine.

The parapet of the roof was cleaned using a Doff machine at 160 degrees. Belzona 3921 conditioner was applied to the substrate and left over night. A first coat of Belzona 3131 was applied whilst laying Belzona 9361 reinforcing sheet over the top. A second coat of Belzona 3131 applied over the top to complete the application. This was completed in accordance with Belzona System Leaflet RPA-06.

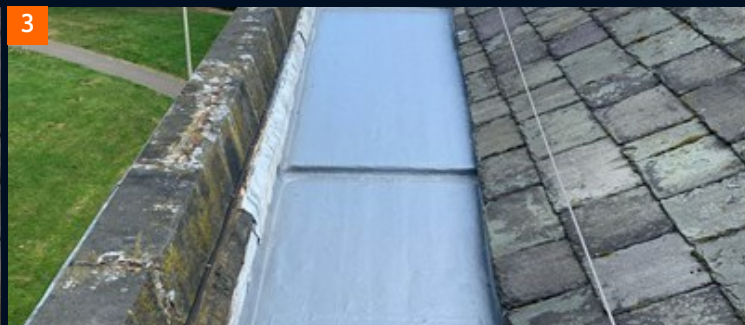
3) Completed Application
