# BELZONA 4131 WASHROOM FLOOR THIRTEEN YEARS LATER

ID: 8355

## PROBLEM

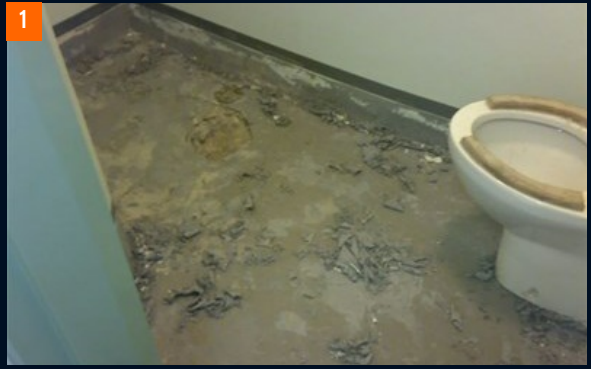
The washroom coating and substrate beneath had collapsed causing health and safety issue for the inmates of this secure unit.

- 1 - Original unrepaired condition
- 2 - Belzona 4131 build in sections
- 3 - Completed Application 2007
- 4 - Condition Assessed 2020

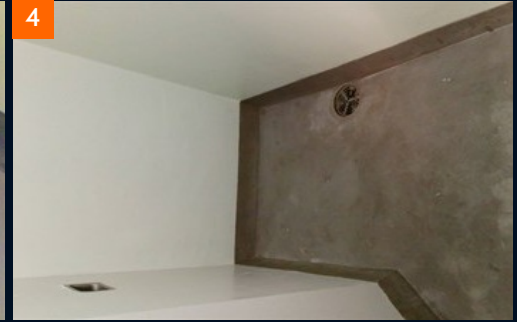
The Client required a seamless floor finish and very safe system which would not degrade. Following this and inspection during 2020, the washroom floor surface was in excellent condition with very little wear. However, other floors had been repaired with cheaper alternative products have now failed and Belzona invited to install some sixteen floors using the Belzona 4131 system
