# BELZONA REPAIRS AND PROTECTS 2 STAGE SEAWATER PUMP

ID: 8356

2 stage sewer pump case

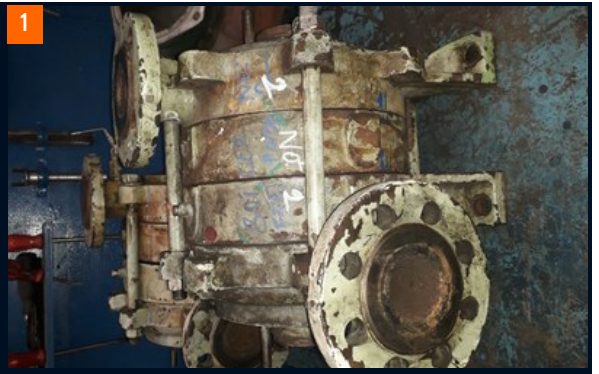
Pump case surface was severely damaged due to cavitation from seawater and corrosion.

1. 2 stages seawater pump with high cavitation
2. After Grit-Blasting
3. Application of Belzona 1311
4. Application of Belzona 1321
