# WELDING SEAMS PROTECTION

ID: 8360

Tank for gasoline storing shows corrosion on the welding seams.

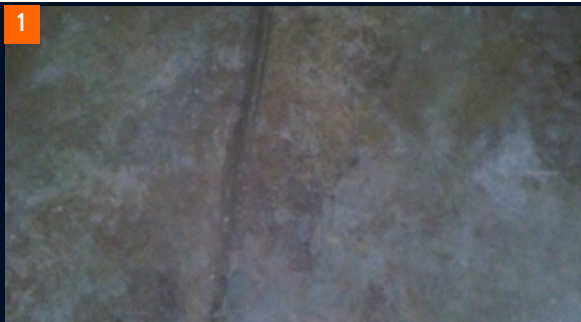
1. Corrosion on the welding seams
2. Welding seams was coated by Belzona 1341
3. Welding seams was coated by Belzona 1341
4. After 4 years no damage was appeared.
