# BELZONA PROTECTS SHIP SCRUBBER SYSTEM DISCHARGES

ID: 8361

Scrubber Overboard Discharge area of RO-RO ship

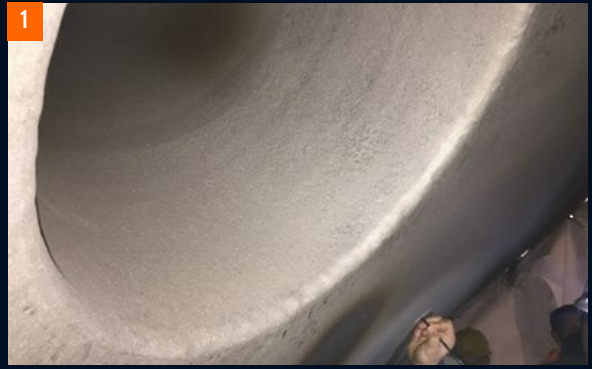
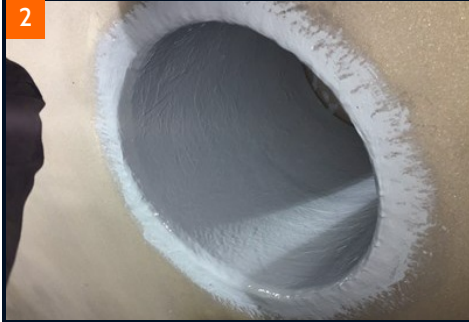
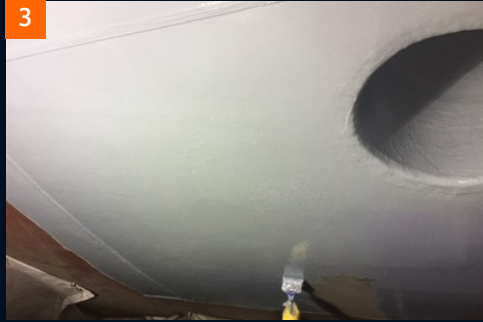
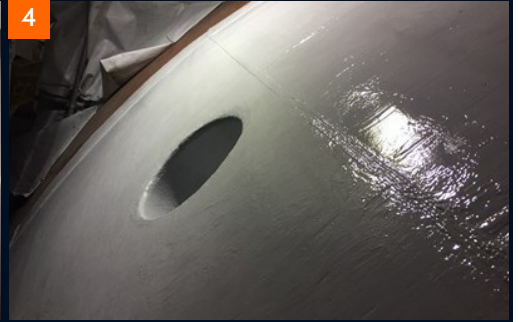
After the installation of the scrubber system discharge pipe, the chemicals included in the system such as sulfuric acid and sodium hydrogen sulphate and etc. will have aggressive corrosive effect on the steel discharge pipe and area around the ships steel hull. Combined with the severe cavitation effects, the area is under heavy risk of metal loss due to cavitation damage.

The application was carried out in accordance with Belzona Know-How System Leaflets SOS-02. Surface was grit blasted to achieve SA2,5 standard. Surfaces salt contaminant measured and surface has cleaned with Belzona 9111 Cleaner&Degreaser. Specified Surface area is coated with 2 layers with Belzona 1391T. After the application, coating allowed to cure and postcured respectively.
