# BELZONA LAYS NEW CHEMICAL FOUNDATION IN FOOD SECTOR

ID: 8365

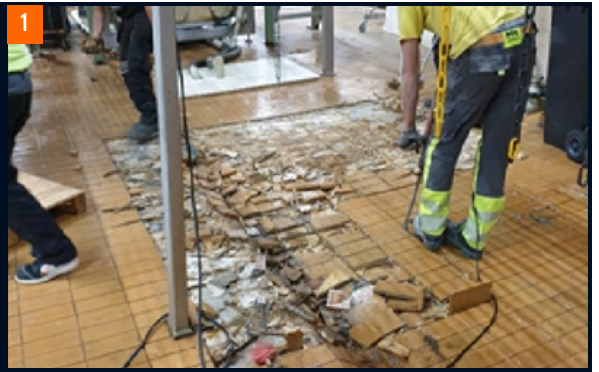
Picture 1 : Old floor de-assembly

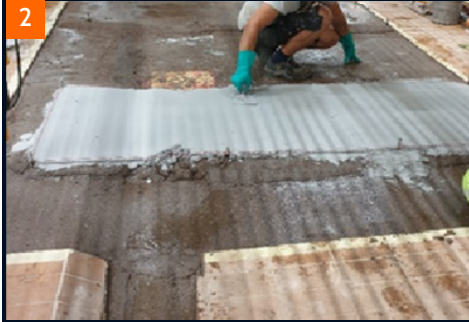
Picture 2 : Deeper areas (2-30cm) filled with Belzona 4154

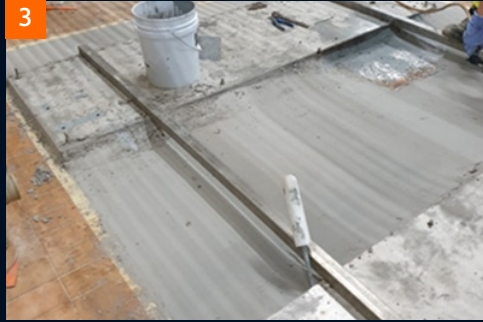
Picture 3 : Belzona 4111 used to reach the final level

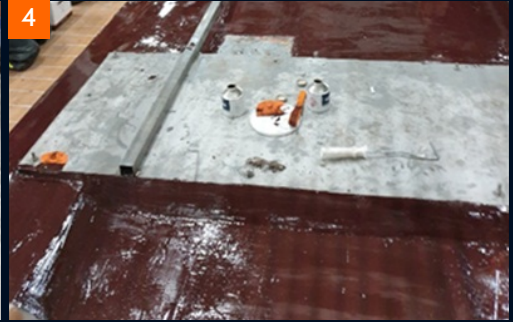
Picture 4 : Belzona 4311 used as a top-coat , a final chemical resistant and safe floor-surface is achieved.
