# BELZONA CONTROLS SEVERE ABRASION IN A CONE CRUSHER

ID: 8366

Cone crusher in a quarry suffers from severe abrasion due to transport of sharp-edged rocks, which scrape and collide against the mantle.

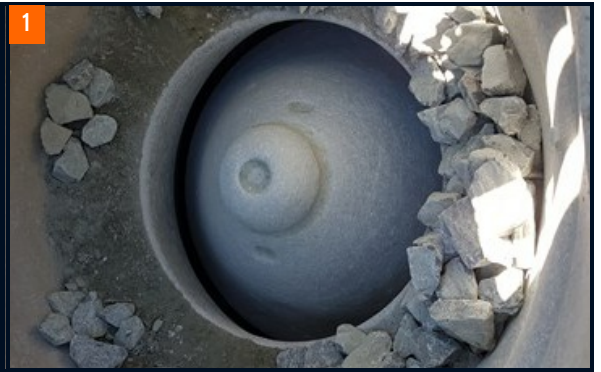
1. Cone crusher - view from above
2. Cone crusher - view from the inside, situation after 11 months of operation
3. Belzona 9811 bonded with Belzona 1121
4. Application finished after grouting with Belzona 1812

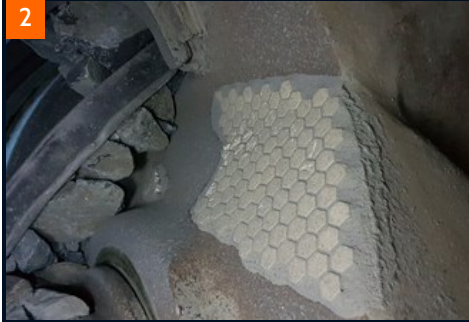
Abrasion is most severe on two positions inside the crusher housing - each size of 20x40 cm. In September 2019, we applied two meshes of Belzona 9811 alumina tiles, bonded with Belzona 1121 and grouted with Belzona 1812. After 11 months, approximately half of the surface was still OK, and the other half (more exposed), needed upgrade.
