# BELZONA REPAIRS VALLEY GUTTERS

ID: 8367

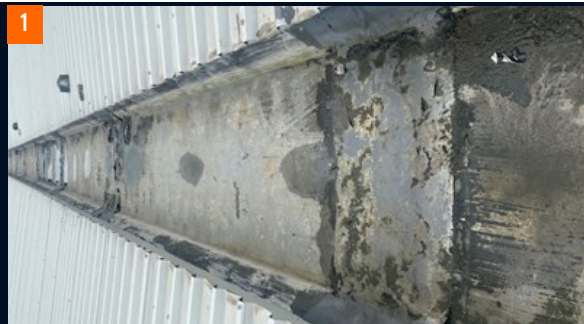
During periods of heavy rain, sheets of water were falling onto production machinery and stock causing major issues. The client requested that the worst affected areas were prioritised and that all the gutters would be treated to repair the leaks.

- 1 - General condition of existing valley gutters
- 2 - Condition of existing valley gutter
- 3 - Completed Works
- 4 - Close up of the completed application

In accordance with System leaflet RPA-06, the gutters were totally cleaned and obvious holes were repaired Belzona 1212. Belzona 3921 (GSC Surface Conditioner) was applied to all surfaces, followed by application of the full Belzona 3111 system.
