# WATER PUMP THAT THE CUSTOMER INTENDS TO REPLACE COMES TO LIFE WITH BELZONA

ID: 8373

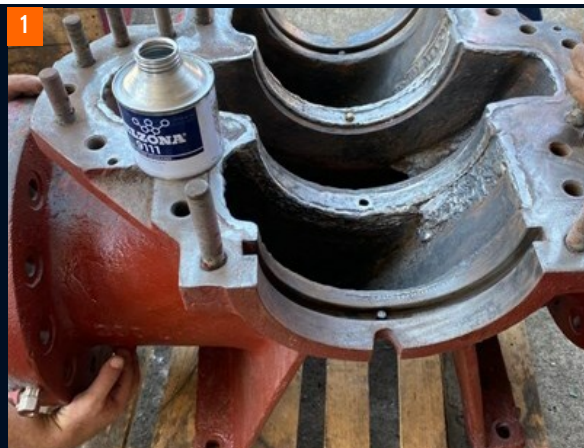
Abrasion caused by corrosion in the pump body as a result of long operating time

1. Belzona 9111 after grit blasting
2. Belzona 1321 coating on Pump Casing
3. Belzona 1321 coating on Pump Casing
4. Belzona 1321 coating on Impeller

The surface was made ready for application by grit blasting in SA 2.5 Standard. The lost surfaces were recovered by filling repairs with Belzona 1311. Then, Belzona 1321 coating was made and the pump body gained high corrosion resistance.
