# BELZONA COATS ENTRY DRIVE ROLLERS WITH A LOW FRICTION COATING

ID: 8376

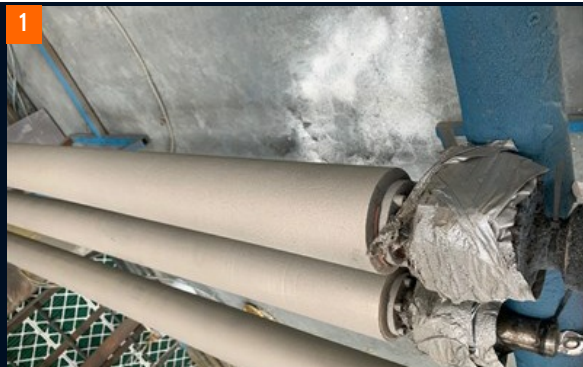
- 1 - Grit blasted substrate
- 2 - First coat Belzona 1341
- 3 - Second coat Belzona 1341
- 4 - Completed bundle of rollers

This is a unique application and has been undertaken by an experienced local coatings contractor for at least five years. Rollers are grit blasted and degreased, with Belzona 1341 applied as a two coat system in accordance with the IFU document. This application is also applied in accordance with a modified version of Belzona System Leaflet SHM-12.
