# BELZONA PUMP REPAIR IN A SUGAR FACTORY

ID: 8380

Repair and coat a Nash vacuum pump in the Sugar Industry.

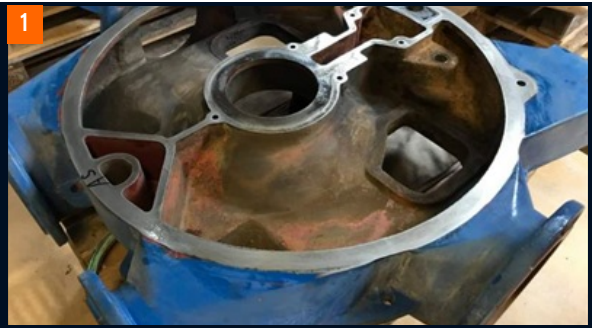
The long running time and high loads resulted in wear damage and corrosion on the housing. The flanges on the housing were washed out by installing the wrong seals.

1: Damaged Pump

The application was carried out in accordance with Belzona system leaflet CEP-3

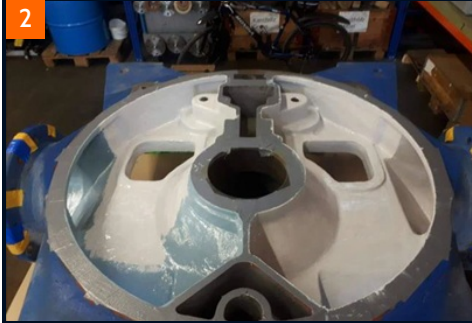
2: Coating Internals of the pump.

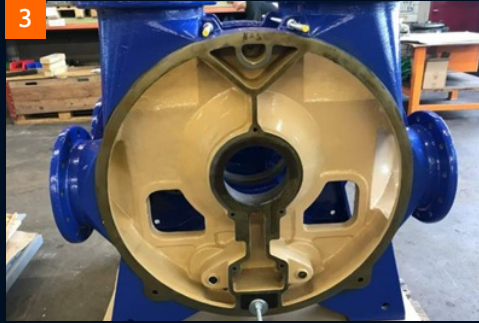
3: Completed Internals of pump.

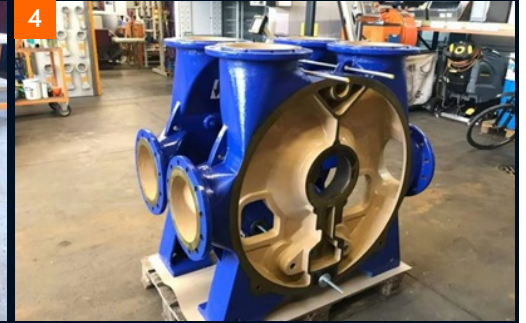
4: Completed Pump
