# PENSTOCK OUTER SURFACE COATED WITH BELZONA

ID: 8383

Hydro Power Plant, TURKEY

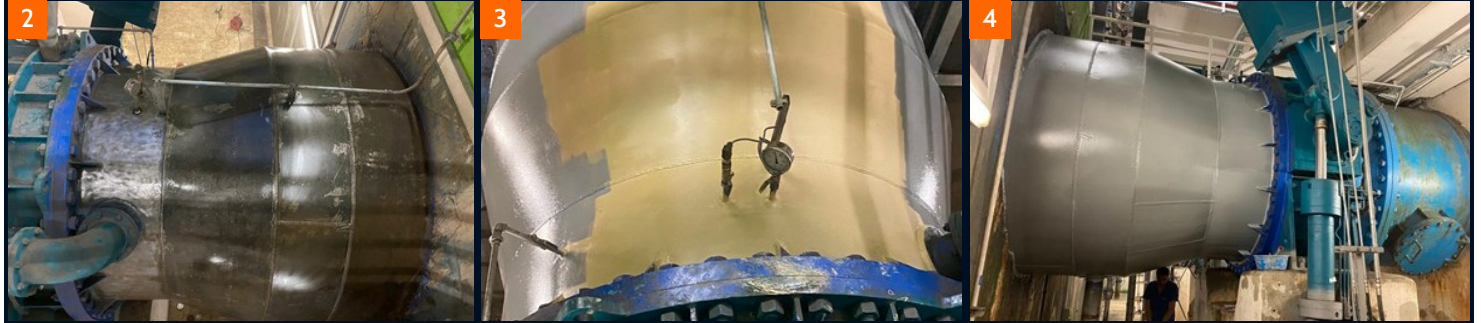
The outer surface of the penstock was constantly exposed to moisture. Previously painting swelled in a short time.

- 1- Before surface preparation, painted surface
- 2- After grit blasting
- 3- When applying the second coat of Belzona 5831
- 4- End of application

The application was carried out in accordance with belzona System Leaflet TCC-03.

After a very good surface preparation, although the surface was moist during application, it was a successful application because the selected Belzona product was suitable for this.
