# CONTINUOUS CASTING LADLE TURRET BEARING REPAIR WITH BELZONA

ID: 8386

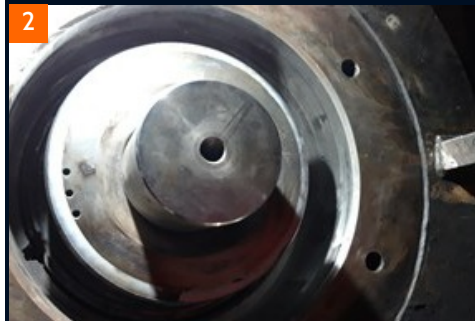
The collapse of one bearing had damaged the bearing seat area putting the machine out of use. The shaft diameter is 450mm and the width of the damage was 200mm with up to 6mm in depth. There were no spares available and due to difficulty in machining the shaft and the tight tolerances needed, Belzona were asked if we could help.

1. Top of the damaged area on the shaft and how access was difficult
2. Overview of the shaft and bearing housing area
3. Former manufactured for this repair
4. Finished repair after removal of the former

System Leaflet MPT-2, for rebuilding damaged shafts using forming techniques
