# BELZONA REPAIR AND PROTECTS SCRUBBER ELBOW PIPE

ID: 8388

On board scrubber elbow pipes of Ro-Ro vessel

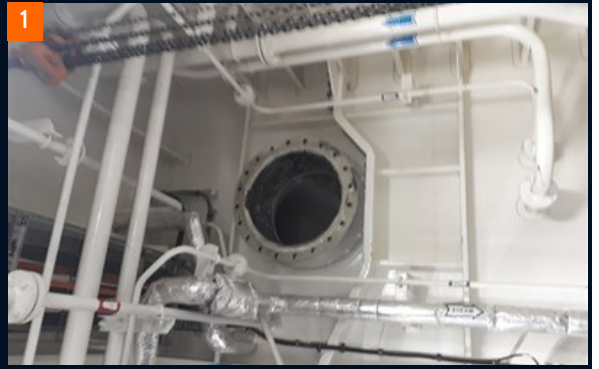
Internal surfaces of scrubber pipes are exposed to high corrosion and cavitation due to corrosive effects of the Scrubber Exhaust Discharge Water.

1. Scrubber Elbow Pipe
2. After first coat of Belzona 1391T
3. After second coat of Belzona 1391T
4. Sponge test on coating

The application was carried out in accordance with Belzona Know-How System Leaflets CEP-03 and CEP-05. Scrubber pipe surfaces have been prepared on board by the shipyard. All surfaces were thoroughly cleaned. Then the damaged surfaces and pittings were repaired with Belzona 1511 Super HT-Metal before coating with Belzona 1391T to provide overall erosion-corrosion and chemical protection.
