# TWO DAY BELZONA REPAIR TO HEAT EXCHANGER

ID: 839

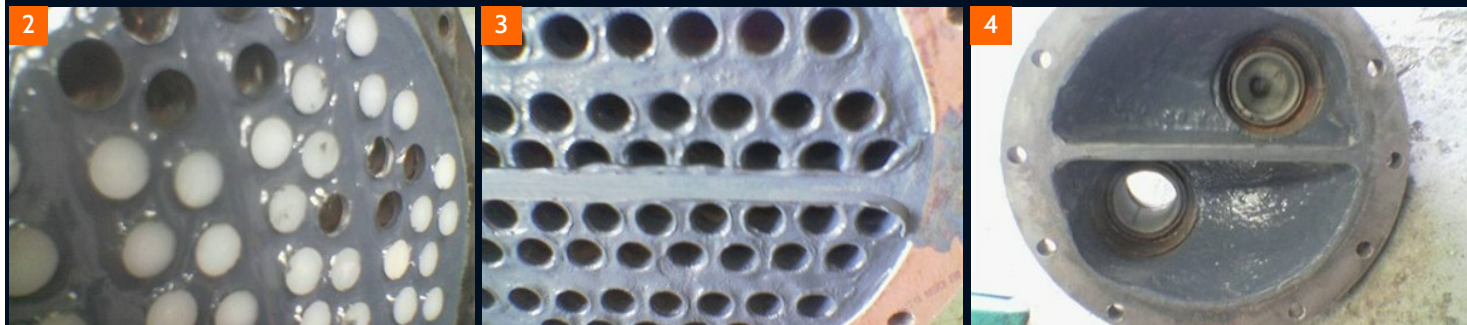
Heat exchanger was suffering bimetallic corrosion (copper tubes, steel tube sheet and cast iron covers), causing leakage on the tube sheet.

1. Severe corrosion after surface preparation
2. Tube ends sealed during application
3. Division bar seal face reformed
4. Rebuilding and coating the end cover with division bar

Application was carried out in accordance with Belzona Know-How System Leaflets HEX-1 & HEX-2.
