# BOW THRUSTER TUNNELS REPAIRED AND PROTECTED WITH BELZONA

ID: 8390

Bow Thruster Tunnels of Ro-Ro Vessel

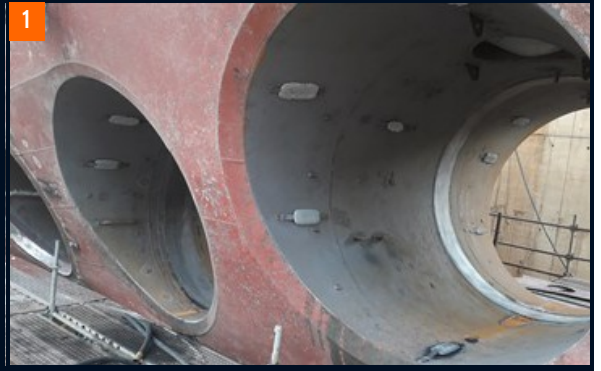
Bow thruster tunnels surface has been damaged and metal loss occurred due to high cavitation environment of propeller projection area.

1. Bow Thruster Tunnels
2. Application of Belzona 1311 for Repairs
3. Application of Belzona 1321 Coating
4. Cured Belzona 1321 Sponge Tested
