# BELZONA DISTRIBUTOR'S OVEN HELPS FOR QUICK RETURN TO SERVICE

ID: 8392

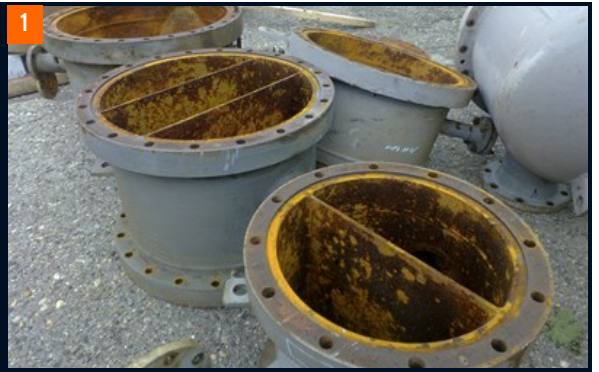
Erosion and Corrosion to the exchanger parts required repairing. Belzona 1391T's time until full service was 28 days in 20°C so post curing was required.

1. Erosion and Corrosion to the exchanger parts required repairing.
2. Blasting and cleaning.
3. Repeated application in 2022.
4. The coated equipment was placed in the oven. The temperature was raised so that the coating was heated to a minimum 50°C for 1 hour.
