# BELZONA CHOCKING COMPOUND STABILIZES A LATHE

ID: 8393

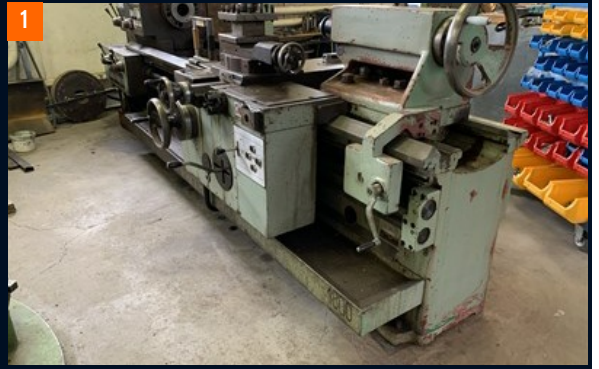
Lathe required a solution to withstand compressive load of machinery and reduce vibrations.

Installed lathe at a machine building manufacturer which required a solid foundation.

1. Installed lathe required a solid foundation
2. Temporary wood dam prepared
3. Pouring Belzona 7111
4. Final Application
