# BELZONA FLEXIBLE MEMBRANE SEALS LEAKING CONCRETE GARAGE ROOF

ID: 8394

Leaking concrete garage roof

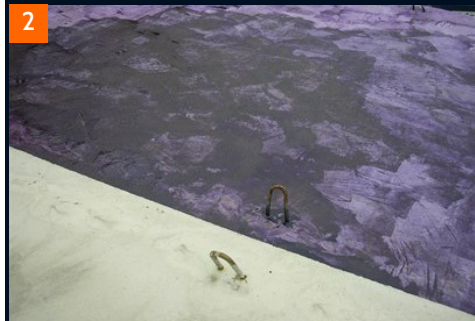
Water, leaking through the concrete roof, was falling on the warehouse goods and damaging it.

1. Leaking concrete garage roof
2. Application of Belzona 3911 to concrete surfaces
3. Application of Belzona 3111
4. Ready to use
