# BELZONA 1593 SPECIAL INTERNAL COATING

ID: 8395

## PROBLEM

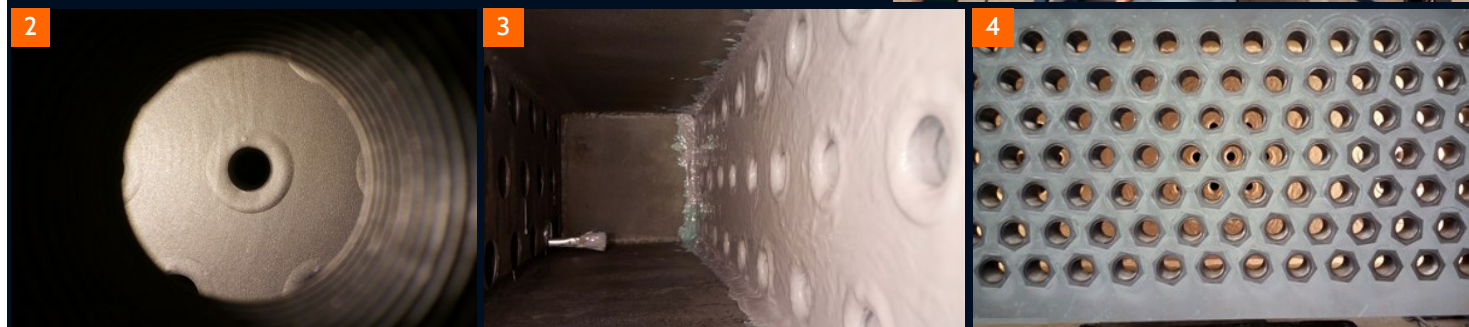
## PHOTOS

Chemical attack (corrosion) was only one problem, another problem was that coating area was not easy available.

Customer needed to protect internal tube sheet of the air condenser. We have offered him product Belzona 1593, which could be used for hydrocarbons in 150°C.

1. Customer needed to protect internal tube sheet
2. We needed to use special tools for blasting
3. Tube sheet was coated with product Belzona 1593
4. Ready to work

We needed to use special tools for blasting through the threaded holes with diameter 18 mm. Also we had to protect that thread. After blasting and cleaning, a tube sheet was coated with product Belzona 1593 in 2 layers. The application was performed in accordance with a modified Belzona system leaflet HEX-03.
