# BELZONA SUPERWRAP II USED AT A SEWAGE TREATMENT PLANT

ID: 8397

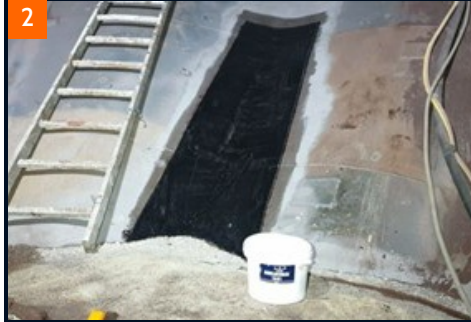
Erosion and perforation at the base off the steel tank.

A length of 2 m and a width of 0.5 m, in the lower part of the bottom of the tank, the steel wall thinned from 5 mm to 4.2 mm; 3.8mm; 2.4mm in one place 1.8mm with one leak (a hole with a diameter of 5mm). It occurred as a result of abrasion in this area and sub-cladding corrosion. The bottom of the tank rests on the concrete foundation. The Tank diameter - 20m, mild steel St3S, conical bottom. The original sheet thickness 5mm. Working temperature in the tank 30-40 degrees C.

Image 1: Internal of the Tank Image

To begin with abrasive blasting were completed in accordance with International Standards followed by removal of dust and degreasing. Repair of perforation and strengthening the shell weld with Belzona 1111 composite Belzona 9341 we completed in accordance with Belzona System Leaflet TCC-01. Belzona SuperWrap II system application was used to repair most areas exposed to erosion then followed by application of Belzona 5821 as a top coat. Completed in accordance with an adapted version of VPF-11 and TCC-03.

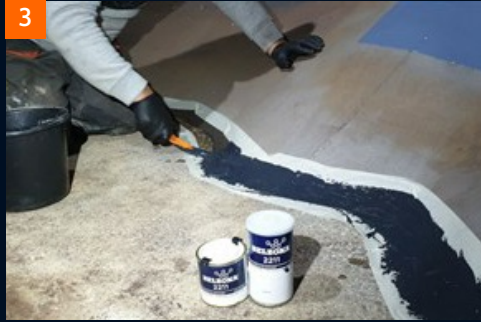
2: Application of SuperWrapp II Image

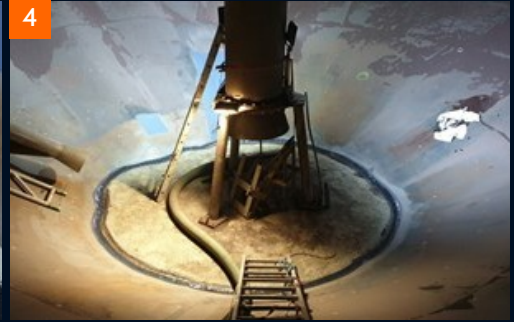
3: Application showing Belzona 5821 & Belzona 2211

Concrete expansion Joints beneath the steel jacket that came in contact were completed in accordance with Belzona System Leaflet FPA-06 where Belzona 2911 and Belzona 2211 were applied.
