# BELZONA 7111 USED TO ISOLATE VIBRATION PADS ON 3 X COMPRESSORS

ID: 8399

The client at a gas power station in Poland needed to isolate the vibration on 3 motor compressors.

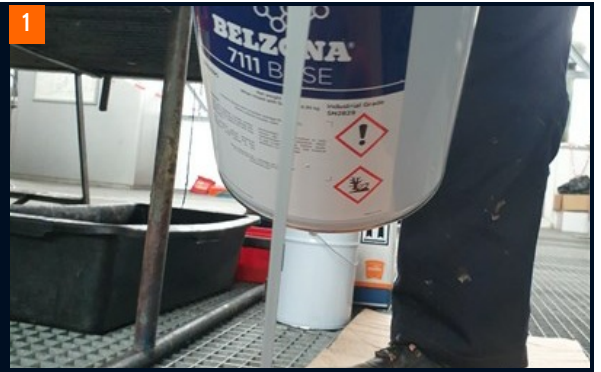
Image 1: Mixing Belzona 7111

In accordance with Belzona system leaflet GSS-12: 1. Unscrew the covers engine. 2. Turning the shaft into check the settings shaft (taking measurements when rotating the shaft, the so-called Springing the shaft) 3. Loosening the screws and screwing in spacer bolts, breaking up the old ones shims 4. Cleaning places of performance (pouring out) new washers 5. Preparation and sealing formwork for pouring Belzona 7111 6. Pouring out of Belzona 7111 7. Removal of formwork and tightening the screws with a force of 1100 Nm

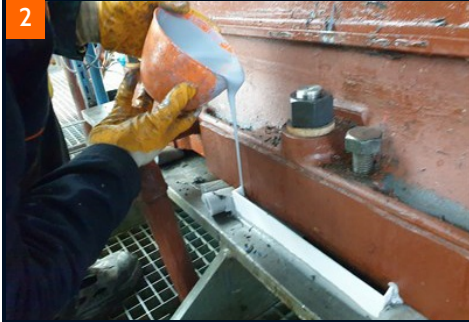
Image 2: Pouring Belzona 7111

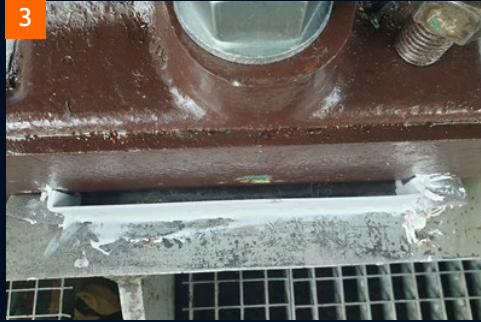
Image 3: Belzona 7111 close up

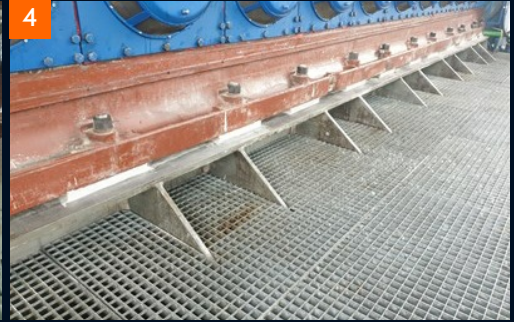
Image 4: Completed Job
