# PINTLE REPAIR WITH BELZONA

Pintle housing on cargo ship.

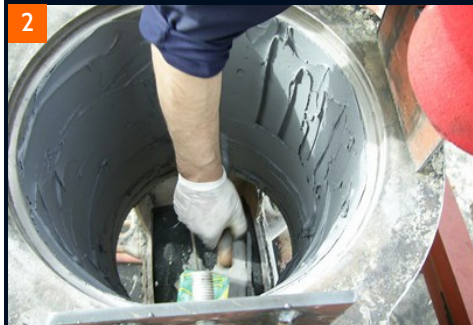
The keyway was damaged by galvanic corrosion and in certain areas the damage reached 40mm in width. Corrosion pitting was severe, up to 12 mm deep in the tapered housing.

1. Prepared Surface
2. Application of Belzona to housing
3. Rebuilt keyway and housing surfaces
4. Fitting the Pintle

Application was carried out in accordance with Belzona Know-How System Leaflet SOS-3. The keyway channel on the rudder was infilled and a new channel machined at 180°.
