# BELZONA REPAIRS DAMAGED BUND WALL

ID: 8400

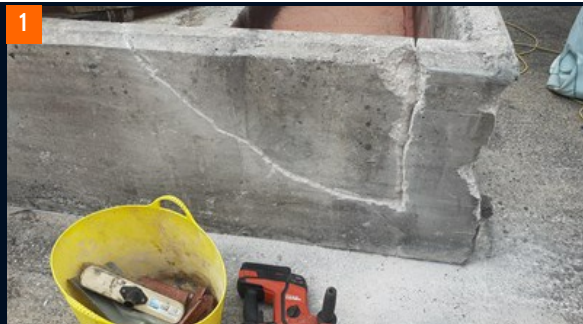
Bund wall and fillet area needed repairing after a collision with a forklift truck caused damage to 2 linear meters of wall to floor joints.

1 - Damage to wall

The products were applied in accordance with Belzona System Leaflet TCC-09. The surface was prepared on the external wall of the bund and rebuilt back to its profile using Belzona 4141. After removing approximately 2 linear metres of fillet, Belzona 4181 was used on the internals to restore the damaged concrete..

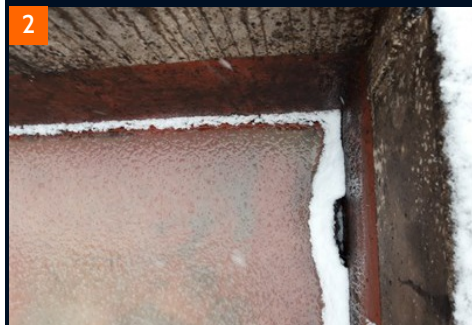
2 - Damage to fillet

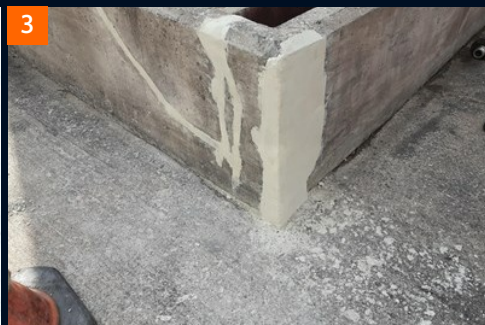
3 - Completed repair to wall

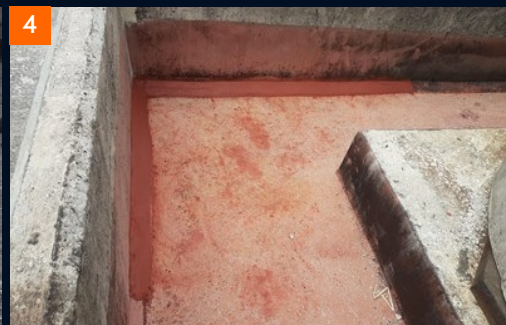
4 - Completed repair to fillet
