# PVC PIPE REPAIR

ID: 8403

## PROBLEM

To use classical kind of repair was problem (too thick wall) also new pipe bend was not available.

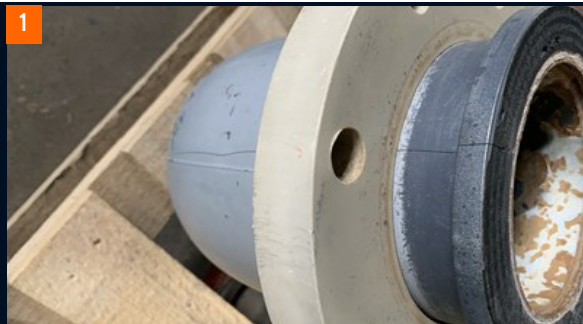
Customer destroyed a PVC pipe bend (diameter 160 mm, wall thickness 10 mm, with hydrostatic pressure, temperature up to 20°C) during some cooling tower dismounting and maintenance.

1. Customer needed to repair the crack
2. We roughened surround place using the Belzona roughing brush.
3. Ready for Belzona 1221 application
4. Repaired pipe bend

The application was performed in accordance with modified Belzona system leaflet VPF-8. Firstly we made the test with Belzona 1221 application on the small area of this bend. Adhesion was perfect. Then we started to repair the entire crack. We terminated the crack by drilling 6 mm hole at the end to prevent further propagation, "veed" out crack with a hand held machine, then roughened it using the Belzona roughing brush. After chemical cleaning was Belzona 1221 applied.
