# BOLSTER SIDE BEARER MOUNTING FACE REPAIR WITH BELZONA 1111

ID: 8404

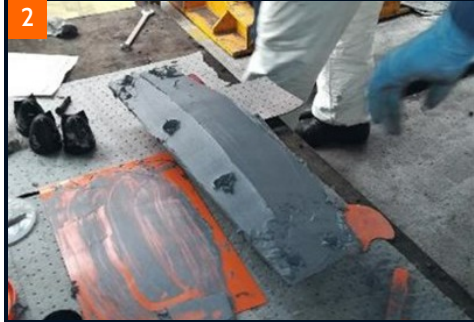
The greatest area of concern is the vehicle bolster structure as this exhibits the most damage and acts as the interface between the side bearers and the vehicle. Exfoliation corrosion has occurred between the body shims and the side bearer top plate mounting on the vehicle bolster structure. This has led to a particularly deep uneven surface caused by the wasting of the original plate thickness on the vehicle bolster. Given this area supports the side bearer, any flexing allowed in the side bearer assembly may have a detrimental effect to the ride quality of the vehicle and the wheel loading's.

Photo 1: The damage on the bolster. Photo 2: The application plates that will be attached to surface using belzona 1111. Photo 3: Belzona 1111 on the application plate in a pyramid form. Photo 4: Finished application.

1. Brushed away loose contamination and degreased using Belzona 9111. 2. All surfaces were prepped using Grit Blasting to give a surface finish of Swedish Standard Sa2½, ensuring a minimum surface profile of 3 mils (75 Microns). 3. Two coats of Belzona 9411 were applied to any areas of the vehicle bolster immediately surrounding the intended repair area for a distance of 25mm (1") to which the Belzona was not required to adhere. 4. Base and Solidifier of 1111 were mixed together thoroughly, until combined with no streaks. 5. Belzona 1111 was applied directly onto the prepared Bolster Side Bearer mounting face surface with a short bristle brush. 6. An excessive quantity of Belzona 1111 was applied to the top surface of the Belzona Application plate face in the shape of an elongated pyramid, with the highest section running longitudinally along the centre of the Belzona Application plate. 7. The Application plate was then pushed onto the guide pin of the bolster surface sufficiently to enable the guide pin nuts to be wound up the guide pins. 8. Once cured the application plate was removed.
