# OVER 40 YEAR OLD CONDENSERS RESTORED WITH BELZONA

ID: 841

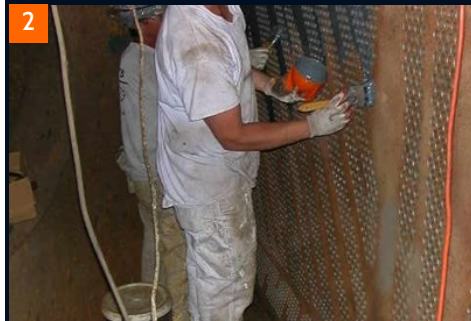
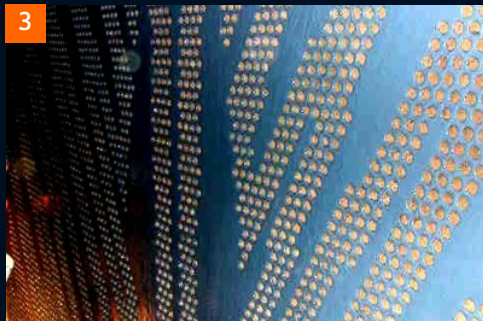
The leaks caused a rise in the condensate return water silicon content from 200 ppm to 4,600 ppm which in turn contaminates the boiler and contributes to corrosion.

Leaks between the stainless steel tubes and Muntz metal tube sheets on eight tube sheets

Application carried out in accordance with Belzona System Leaflet HEX-1 & HEX-3.
