# BELZONA 1813 PROTECTS A FAN WHEEL AT A GRAVEL PLANT

ID: 8410

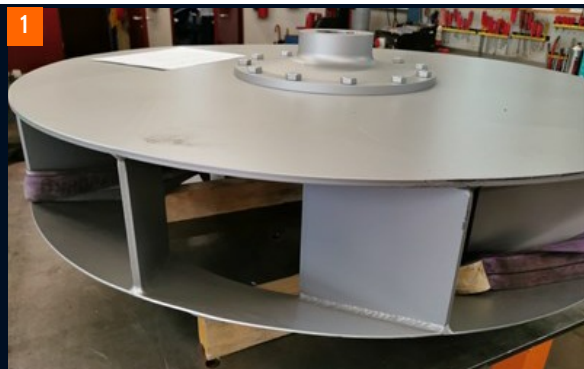
Image 1: Fan Impeller Grit Blasted Image 2: Belzona 9811 Applied onto Belzona 1391T Image 3: Belzona 1813 applied to the Belzona 9811 Image 4: Complete Application

The fan impeller was grit blasted in accordance with the standard Belzona surface preparation. They then applied Belzona 1391T and attached the Belzona 9811 Alumina tiles to offer extra abrasion resistance and grouted with Belzona 1813 in accordance with a modified version of Belzona system leaflet SHM-7.
