# BELZONA HELPS GIVE A SHIP CAISSON A MAKEOVER

Belzona's Distributor for the West region of France, completed a large project at the port of Brest, which was to repair two bearing surfaces on a ship caisson. This particular application required highly skilled technical knowledge and was a very profitable opportunity due to the significant quantity of products involved. The Client required an effective and timely solution as these repairs were hindering the activity of the shipyard.

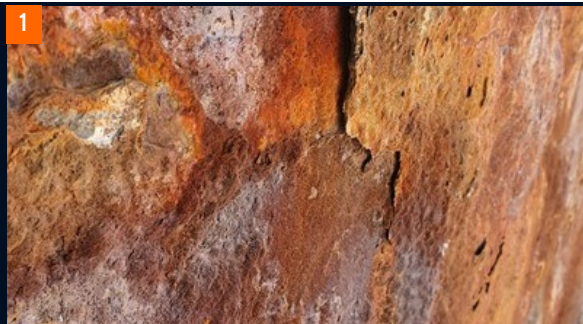
The ship caisson was experiencing severe corrosion which deteriorated the surfaces in contact with the mobile gates. This deterioration led to the material loss of the lateral plates substrate to which the gates press against and form the seal. This meant that the creation of a watertight seal by the caisson and the gates could not be ensured, and therefore making the caisson not fit for its operational purpose. The main issues that the ship caisson was experiencing were:

Several losses of thickness all over the surface with some more specifically deteriorated areas.

Severe wear on the central part which adheres to the gates on a surface of 45 cm (caused by a combination of marine corrosion and joint friction) which led to 20 mm of lost thickness.

1. Sever deterioration of substrate
2. Ready for Surface Preparation
3. Resurfaced and protected substrate
4. Ship caisson repaired and ready to operate again
