# PHARMACEUTICAL PLANT USES BELZONA SAFETY GRIP SYSTEM

ID: 8418

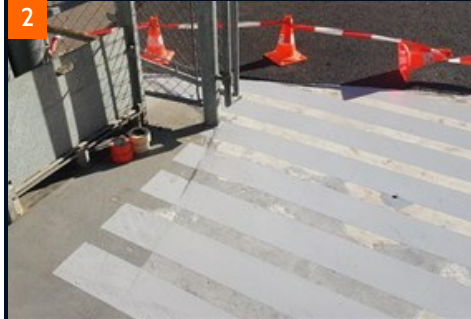
Image 1: Application of Belzona 5231

Areas of concrete were repaired with Belzona 4111. The Belzona 5231 was then applied in accordance with System leaflet FPA-8 to the concrete and then the Belzona 1821 and Belzona 9211 grip system was used to create a safety grip system then overcoated with Belzona 5233 for increased UV Stability.

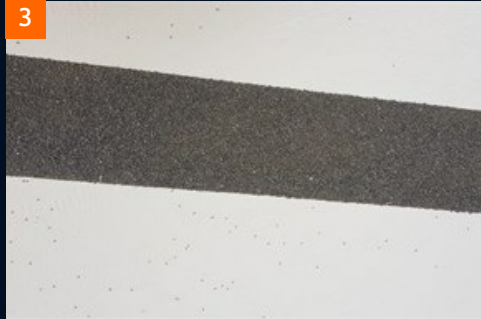
Image 2: Strips of Belzona 5231

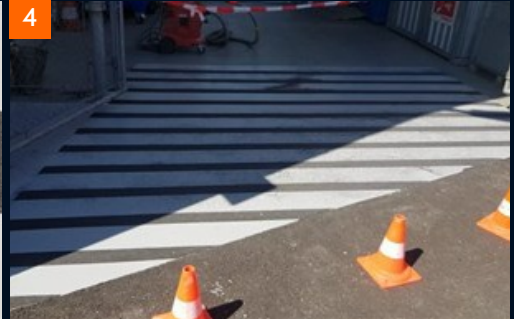
Image 3: Close up
