# BELZONA KEEPS FISHING FOR 20 YEARS.

ID: 8427

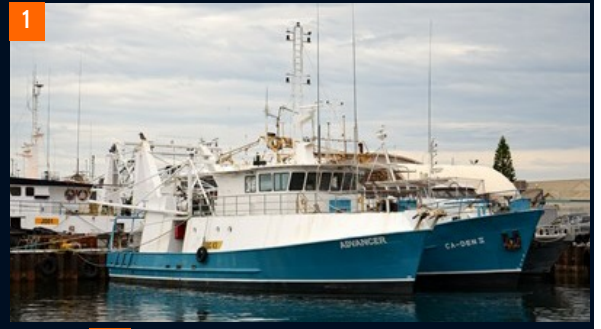
1. Fishing Trawlers
2. Stern ramp deck prior to repair
3. Close up of original 20 year old Belzona 4000 product
4. New repairs complete.

The localized areas were mechanically abraded and the Belzona 4111 was troweled into the areas to be patched.

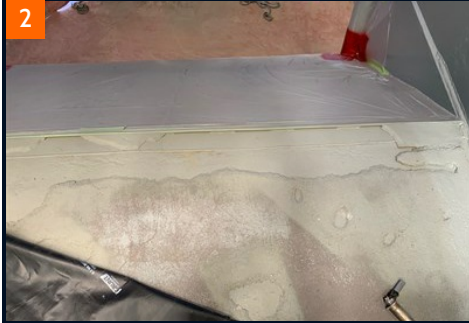
Now in 2020, some 20 years after the original application, some localized areas required attention and re-laying of Belzona 4111.

The area adjacent to the stern ramp of the trawling vessel is a constant trafficable area for the crew as well as weighted nets full of the catch of the day being dragged across the deck. Back In 2000 the engineer in charge applied one of the Belzona 4000 products to the deck area for non slip and durability.

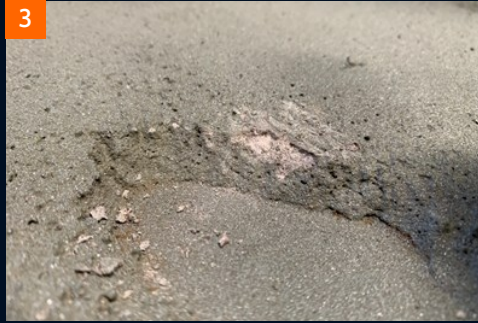
The same engineer applied both Belzona products some 20 years apart - it was very evident that the original Belzona was extremely durable and robust making the decision to carry out the patch repairs with Belzona a very easy one.
