# BELZONA REPAIRS TO ROOFTOP EXHAUST DUCTING

Rooftop exhaust ductwork

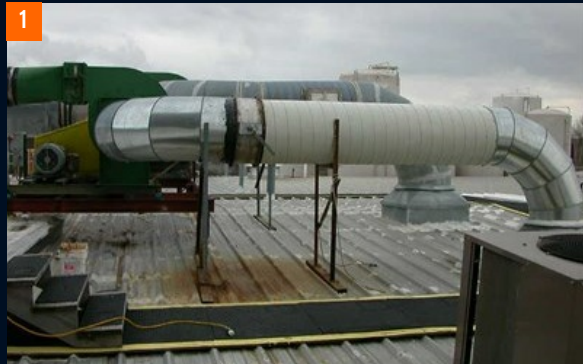
Joints were leaking allowing escape of unpleasant gases into the neighbourhood leading to many complaints.

1. First duct joint
2. Close up of first joint repair
3. Second joint repair

Application carried out using a modified Belzona System VPF-11a

Belzona 2211 (MP Hi-Build Elastomer)
