# AXIAL FLOW PUMP COATING WITH BELZONA

ID: 8435

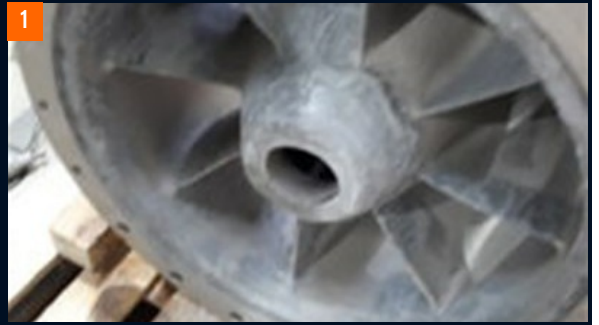
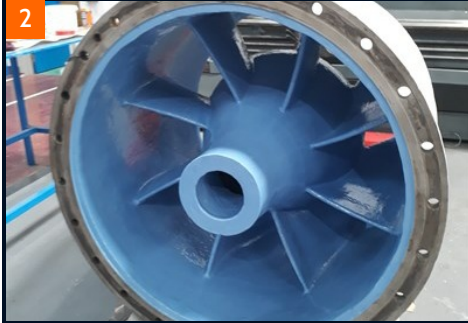
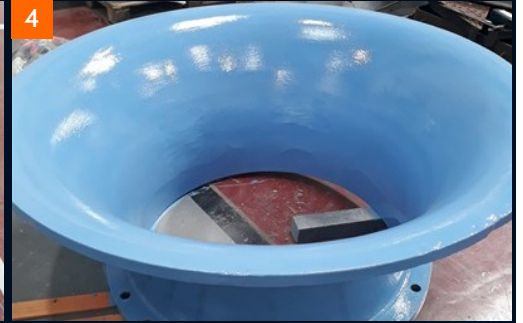
The diffuser vanes of the pump has suffered extensive damage from erosion. Due to the age of the pump spare parts were not available & a replacement diffuser would need to be fabricated from new (the cost would be approx. £40,000).

Suction Bell Suction bell coated with Belzona 1341 Part coated with Belzona 1341 Part coated with Belzona 1341

The parts were grit blasted to SA2.5 & 75 microns. The diffuser vanes & other damaged parts were rebuilt using Belzona 1311 as per CEP-01. The area was then coated with Belzona 1341 as per CEP-03.
