# BREWERY SUGAR STORE DRAIN REPAIRED WITH BELZONA

ID: 8437

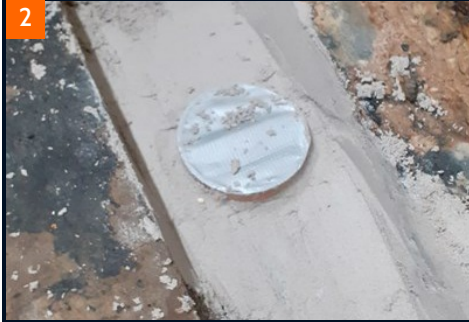
1. Completed works awaiting curing, prior to refitting drain covers 2. New shoulders and downpipe formed 3. New downpipe and central section formed

On removal of all the superficial damaged substrate it was noted that there was far more excavation to be done than first thought. All the wet material was removed back to a solid surface. The drain downpipe had collapsed and the distributors engineers fitted a new one made up from standard parts from a builder's yard, adapting, cutting and fitting it to suit. The drain profile was formed by hand from Belzona 4131, installing plastic sections, again made for the actual installation from other parts, and the new shoulders for the drain were formed. On removal of all the formers, the drain was back to the size and standard required, leaving the customer extremely happy.
