# REINFORCEMENT OF SEWAGE PIPELINE WITH BELZONA SUPERWRAP II IN A SEWAGE TREATMENT PLANT

The Pipeline at a Sewage Treatment Plant in Poland had suffered thin-wall defects in four stub pipes DN600.

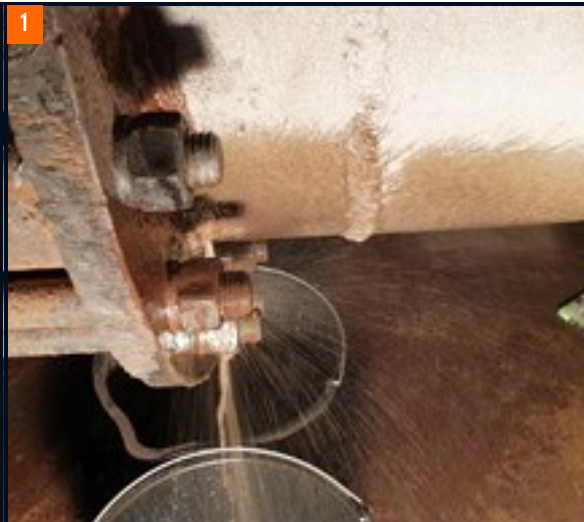
The pipe eroded over time and this resulted in a weakening of the pipe wall and weld seams. The pipe wall was very thin and there was a risk of an ecological disaster. As the pipe could not be cut off, a cold applied Belzona repair was chosen.

Image 1: Leakage on the asset

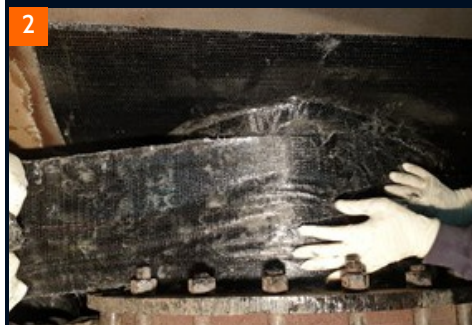
Image 2: Reinforcement Application

The application was carried out as per the Belzona System Leaflet VP11 and Belzona Superwrap II method statement provided. Belzona 9611 and Belzona 1221 were used to successfully to stop the leak within minutes. Following thorough grit blasting all pitting and weld seams were filled with Belzona 1111 and Belzona 1161, which accounted for about 90% of the substrate surface. After that the Belzona Superwrap II system was applied. Finally it was coated with Belzona 5811.

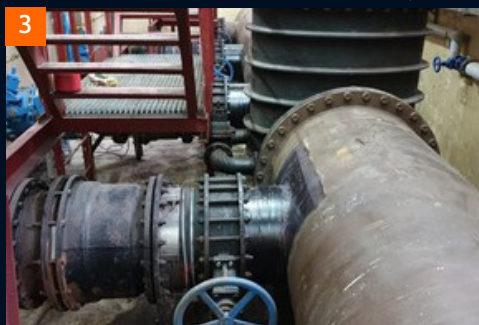
Image 3: Super Wrap II Complete

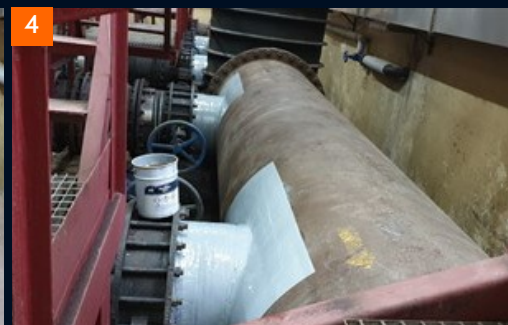
Image 4: application Complete with a coat of Belzona 5811
