# WEATHERPROOFING ELECTRICAL ZIPPER BOOTS THE BELZONA WAY

ID: 8440

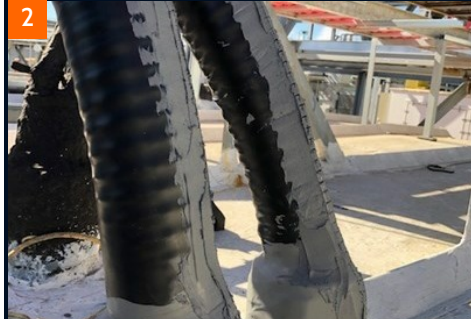
Weather deteriorated the original zipper boot causing water penetration inside the panel leading to power failure.

1. Unprotected electrical zipper boots
2. Applied Belzona 1121
3. Applying Belzona 9341 and Belzona 3121
4. Finished weatherproofed electrical boot

After removing any loose debris we then cleaned each boot with 9111. We then applied the 1121 to each side of the zipper to create a more uniformed surface area. Once the 1121 cured we then applied a coat of 3121 to the zipper boot. The applying the 9341 wrap at a minimum of thirty-six inches in height. Once the wrap was was competed we then added the final coat of 3121 over the wrap completing the job.
