# BELZONA PROVEN CAVITATION PROTECTION TO A FRANCIS TURBINE

ID: 8443

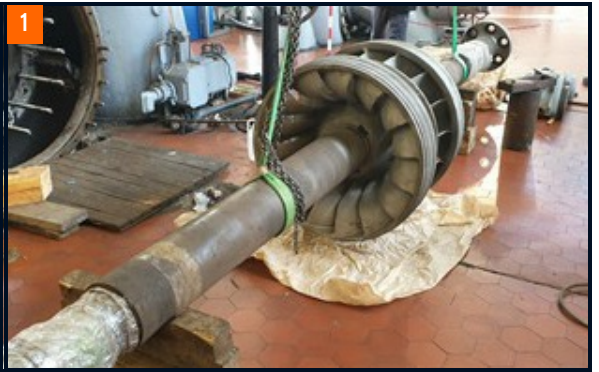
Cavitation has caused erosion of the parent metal and loss of performance of the turbine.

1. Turbine after grit blasting

The application was carried out in accordance with the Belzona Know-How System Leaflets CEP-3 and CEP-5. Firstly, metal loss was repaired with Belzona 1221. Once the damaged areas had been repaired, the turbine runners were completely coated with Belzona 2141.

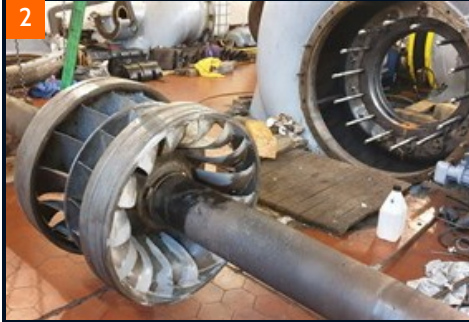
2. Repaired with Belzona 1221

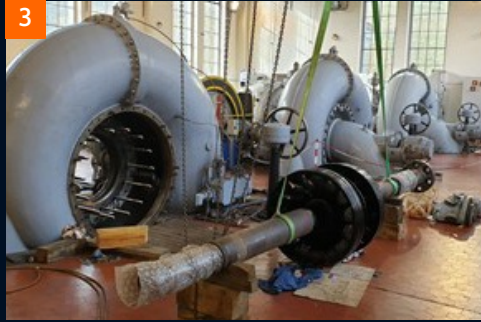
3: In Progress

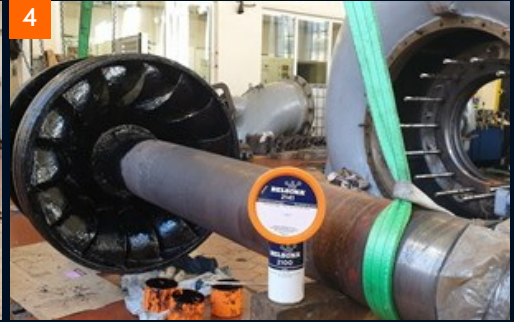
4: Coated with Belzona 2141
