# STRENGTHENING CORRODED STORAGE TANK WITH BELZONA

ID: 8444

A carbon steel storage tank (18m in diameter and 11m high) on a chemical plant, for EDC storage.

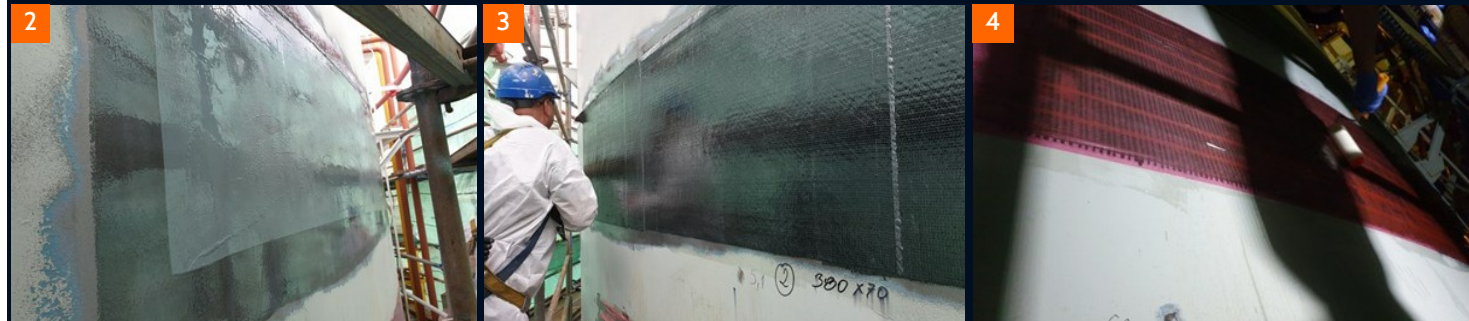
Numerous areas of the tank had a loss of thickness due to corrosion.

1. Rebuild defects using Belzona 1111
2. Wetted out substrate with Belzona 1981
3. Applied wetted out reinforcement sheet Belzona 9381 to repair area.
4. Consolidated finished application using Belzona 9382 before overcoating with Belzona 5811

The application was carried out in accordance with the Belzona System Leaflet VPF-11
