# BELZONA PROTECTS NEW BUTYL GLYCOL ESTERS TANKS

ID: 8446

Butyl glycol esters tanks needed a protective coating.

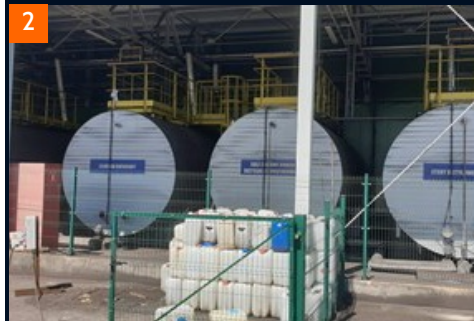
1. Asset Location
2. Butyl glycol esters tanks
3. Previous coating corrosion protection damage.
4. Inspection after one year

The client had used a cheap coating in containment area first and after it failed decided to spend a little more money to make it last a long time. Belzona 4311 was applied into the internal lining of the tank and is still in good condition.

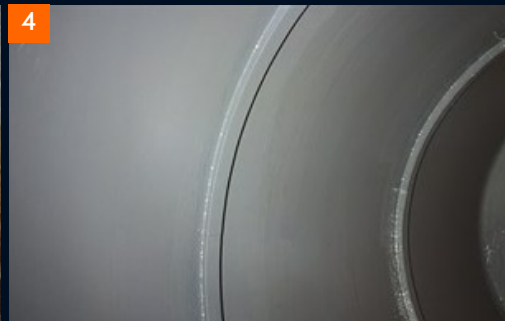
Internal corrosion of tanks damaged due to corrosion and failure of previous coating.
