# BELZONA HELPS PROTECT OFFSHORE PLATFORM LEGS AT A WATERLINE

ID: 8447

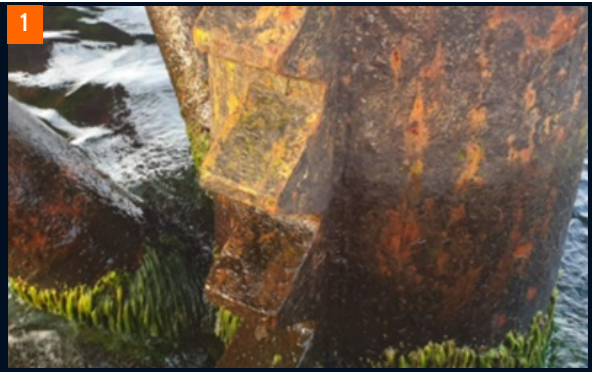
Corrosion of platform legs in the splash zones.

Original corrosion protection damaged on platform legs.

1. Corroded platform legs
2. Surface preparation
3. Belzona 5831 in use.
4. Platform

Application was carried out using a modified version of Belzona Know-How System Leaflet SOS-21. After wet abrasive blasting the Belzona 5831 was applied to the corroded areas above the waterline.
