# PROTECTION OF BIOMASS INCINERATOR CHUTES WITH BELZONA

ID: 8448

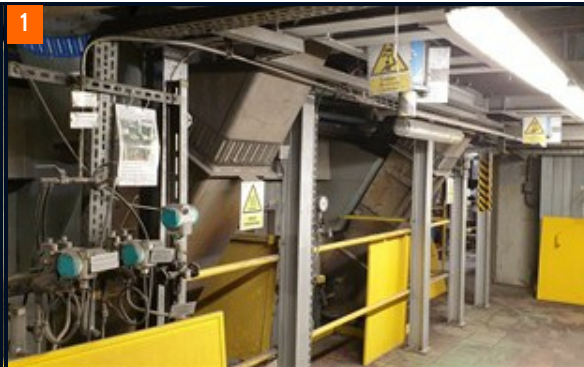
Excessive wear of stainless steel chutes when operating at elevated temperatures. The client was looking for a long-term solution to protect the substrate.

1. Chutes in the Biomass Plant
2. Application of Belzona 9811
3. Application of Belzona 1813 grouting  
Belzona 9811
4. Complete Application using Belzona 1811
